ANALYSIS OF SPACECRAFT ON-ORBIT ANOMALIES AND LIFETIMES

PRC R-3579
10 FEBRUARY 1983

Prepared for
National Aeronautics and Space Administration
Goddard Space Flight Center

Prepared by
Charles Bloomquist
Winifred Graham

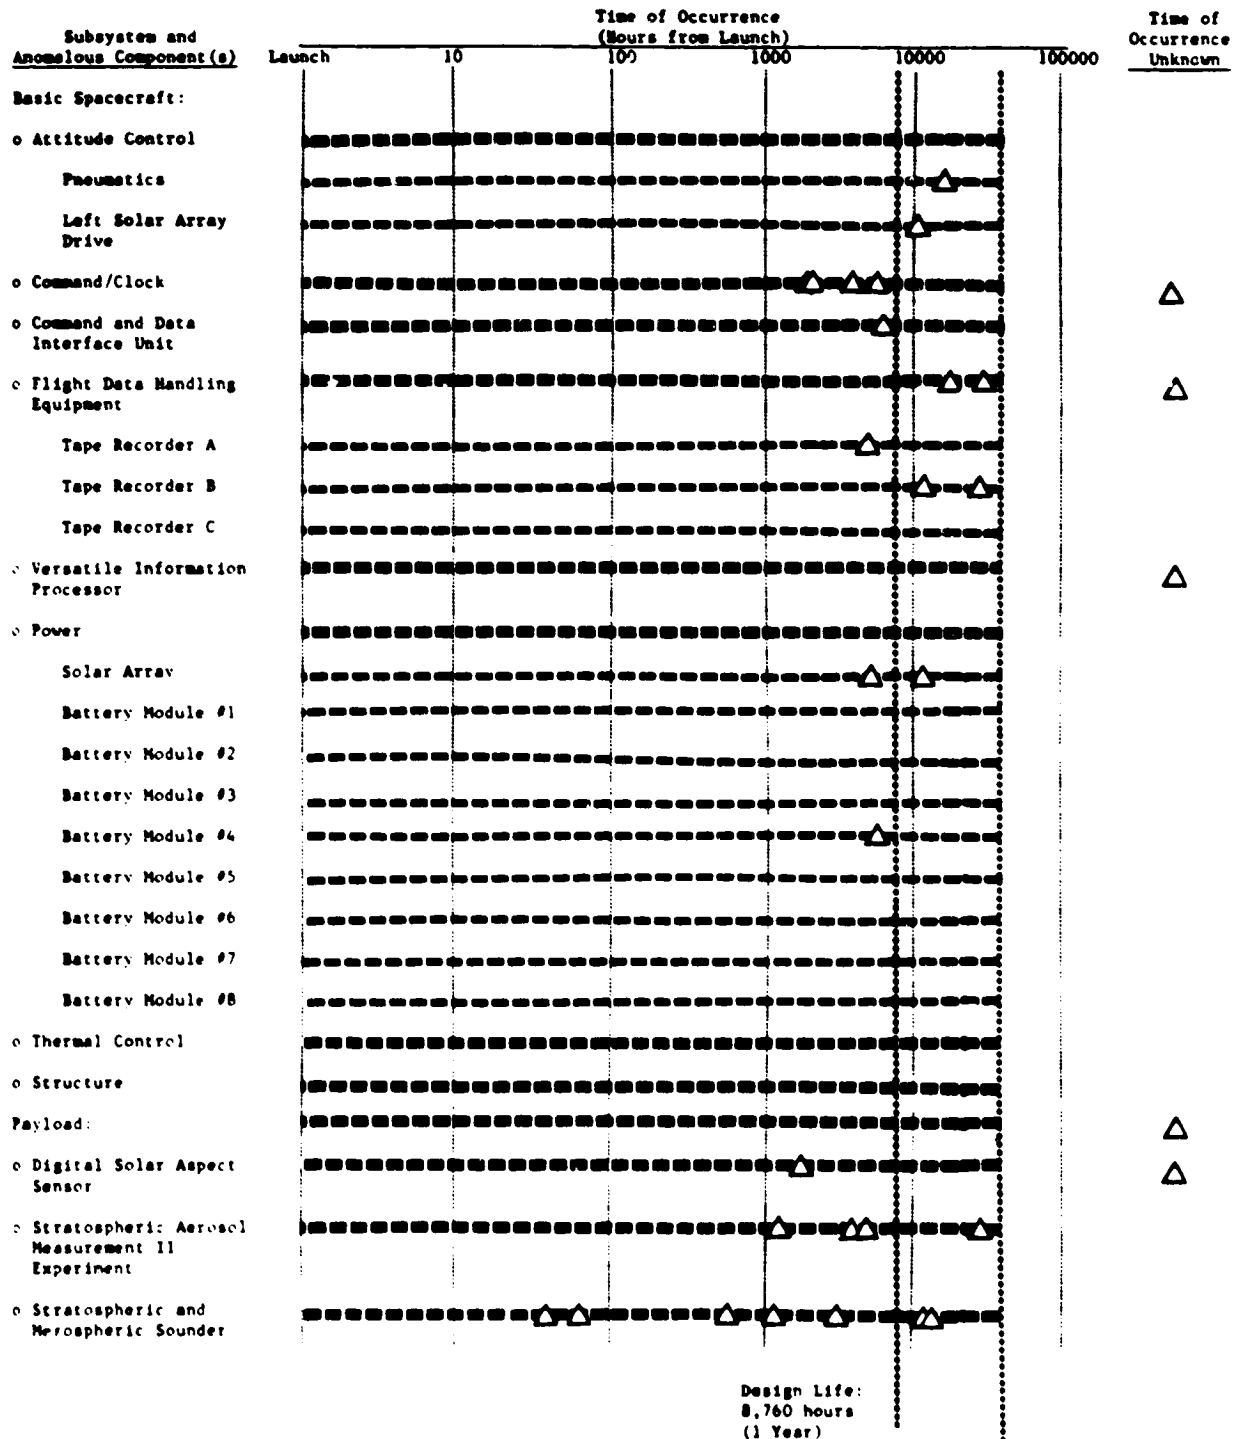
PERFORMANCE SUMMARY FOR NIMBUS-7

Design Life:
8,760 hours
(1 Year)

End of Data:
33,000 hours,
end of report study
period--NIMBUS-7 is
still operating.

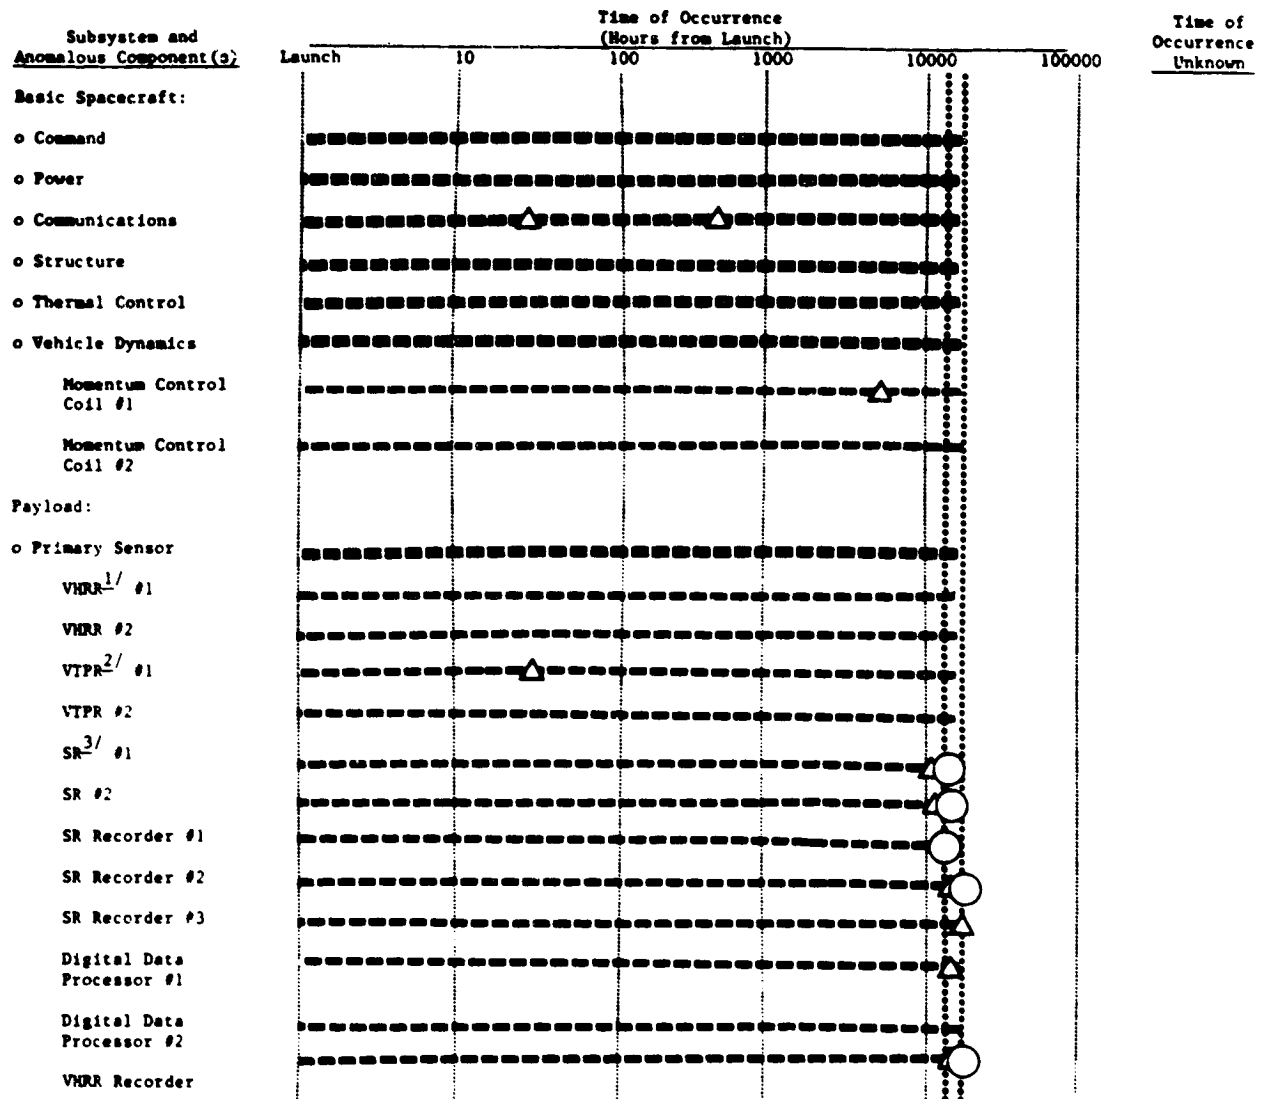
Design Life:
17,520 hours
(2 Years)

End of Data:
22,100 hours;
NOAA-5 mission terminated
after 17 additional months
of limited operation.

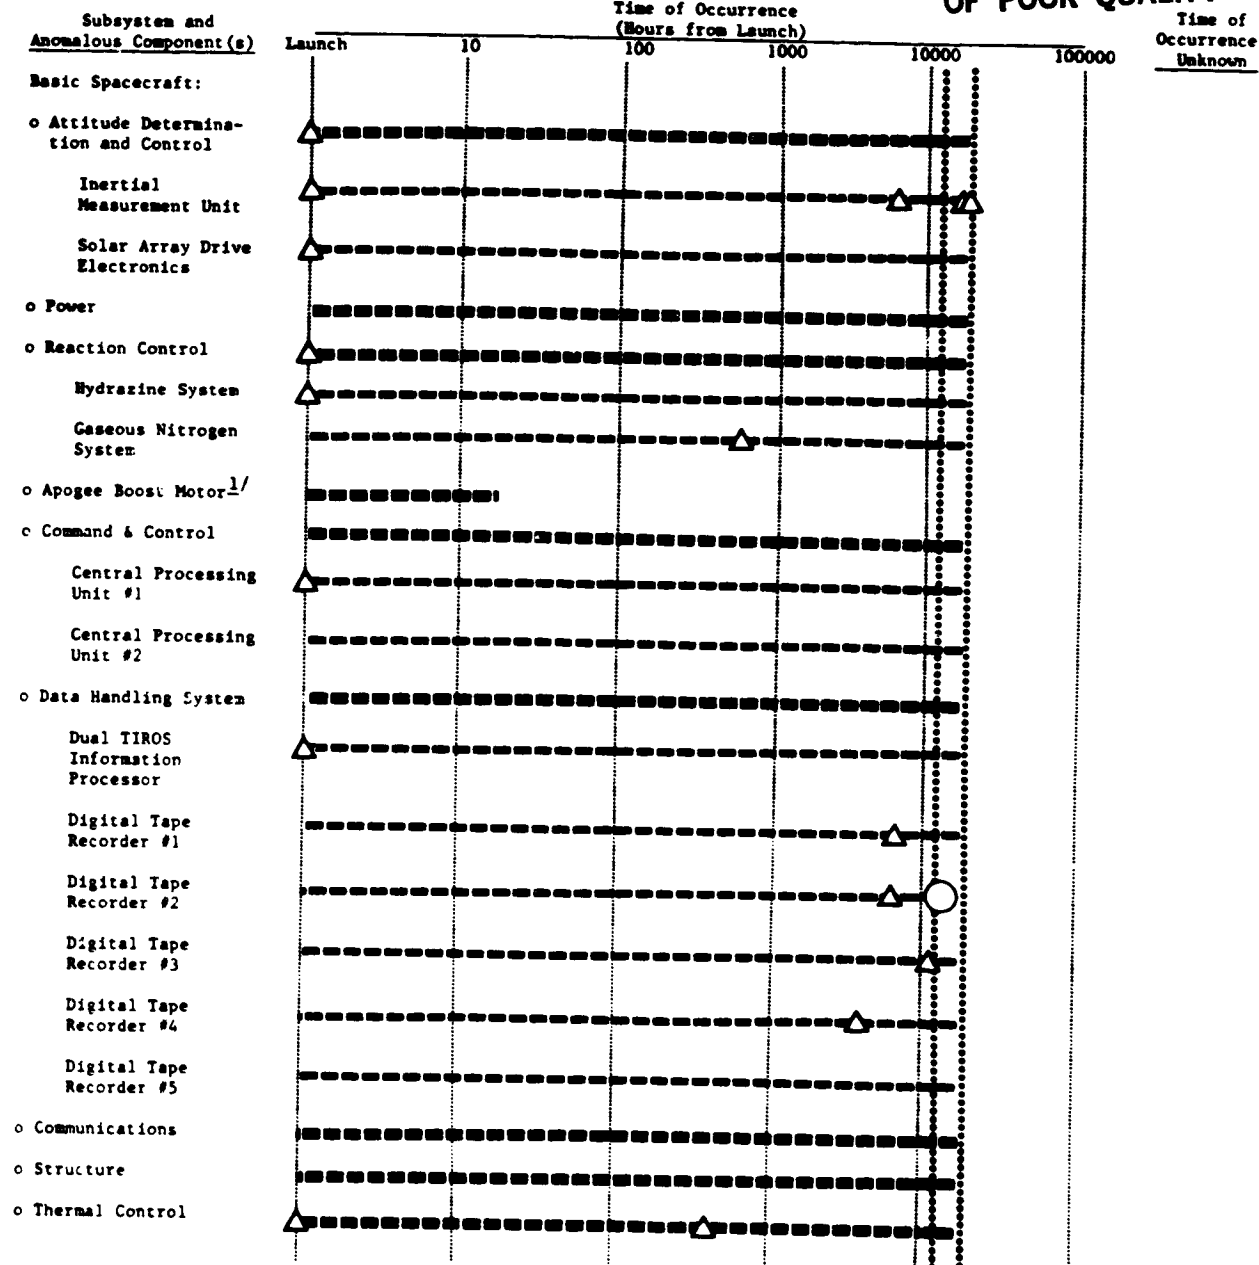
PERFORMANCE SUMMARY FOR NOAA-6

Design Life:
17,520 hours
(2 Years)

End of Data:
26,352 hours;
end of report study
period; NOAA-6 is
still operating.

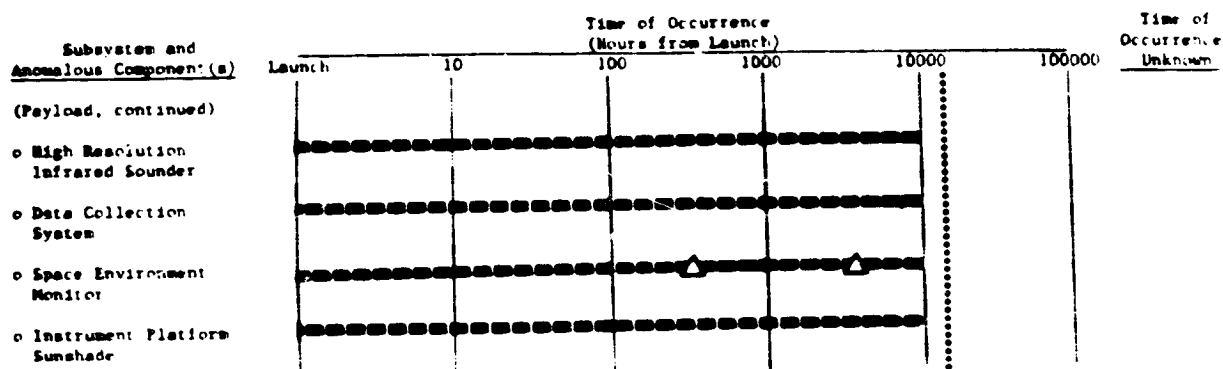
PERFORMANCE SUMMARY FOR NOAA-7
(Continued)

End of Data:
8,928 hours,
end of report study
period--NOAA-7 is
still operating.

Design Life:
17,520 hours
(2 Years)

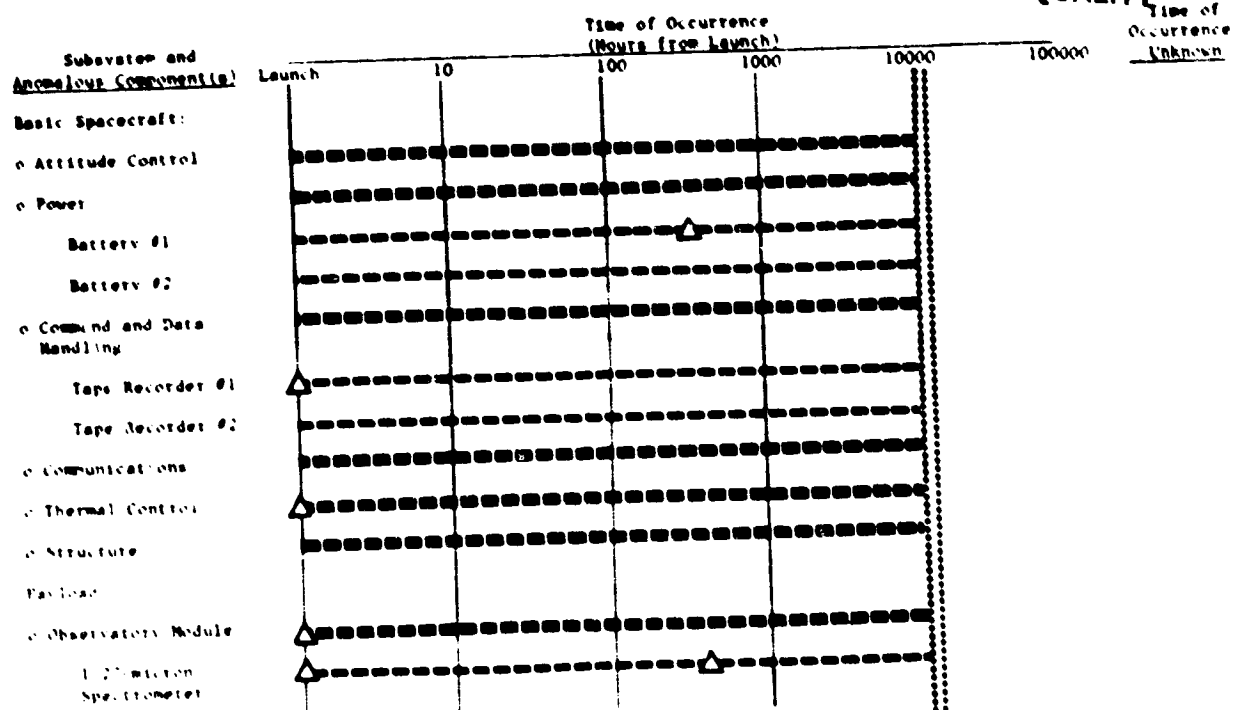
PERFORMANCE SUMMARY FOR SMI

End of Data
10,130 hours,
end of report
study period--
SMI is still
operating

Design life
17,520 hours
(2 Years)

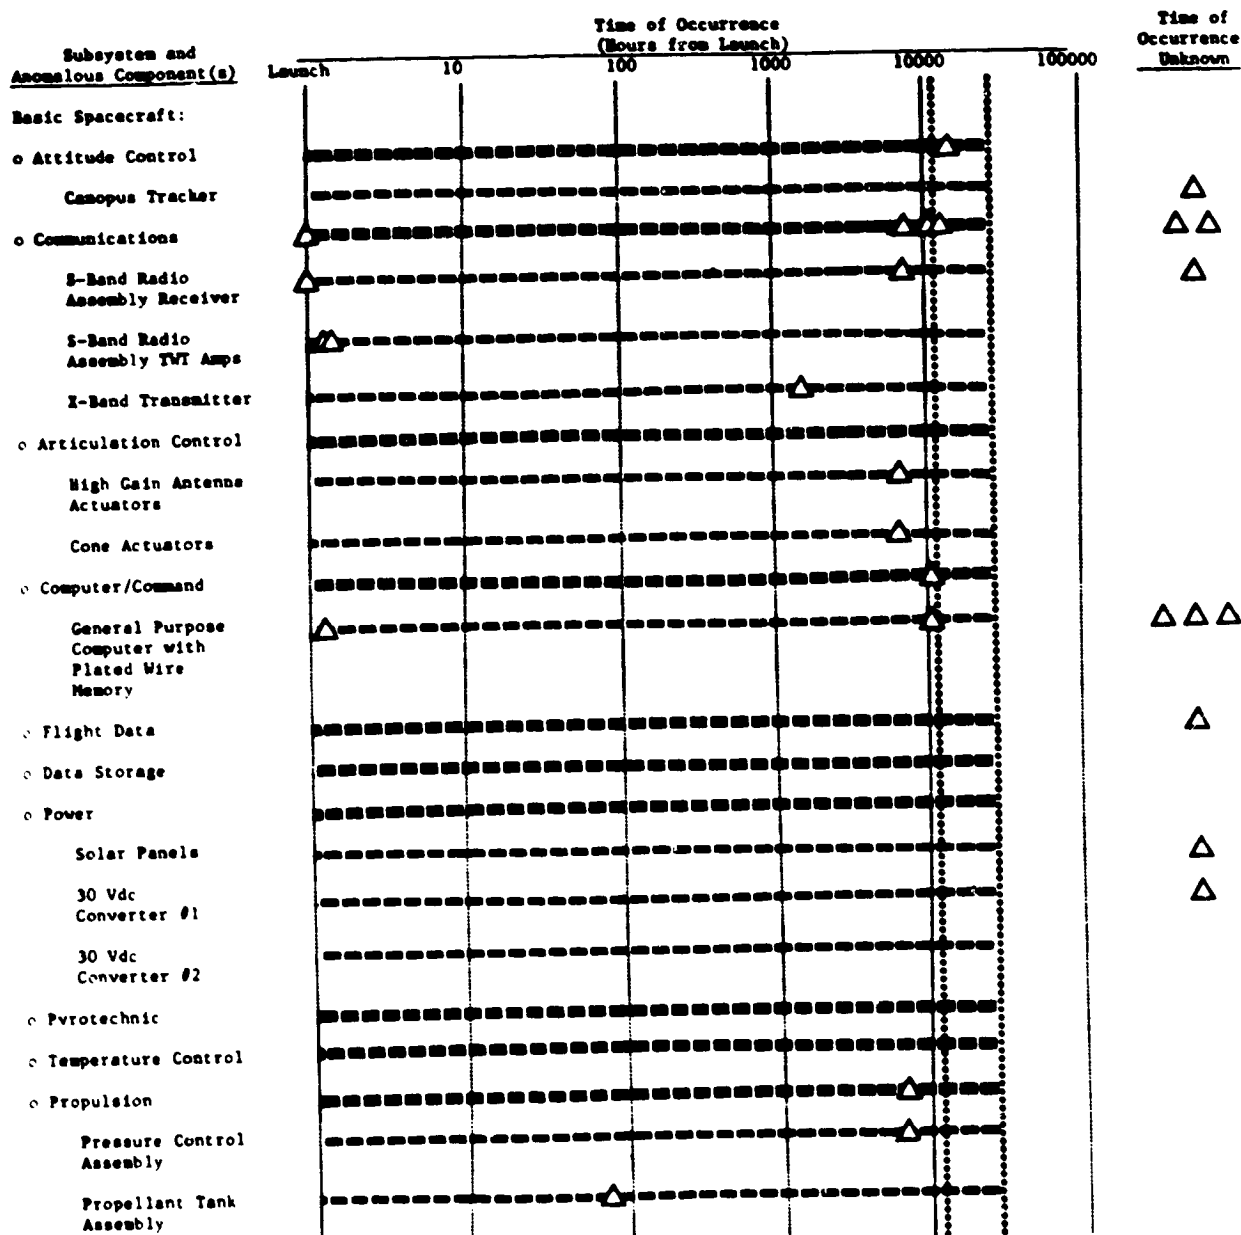
PERFORMANCE SUMMARY FOR VIKING ORBITER 1

Design Life:
11,088 hours
(15 Months)

End of Data:
42,936 hours;
Viking Orbiter 1
deactivated.

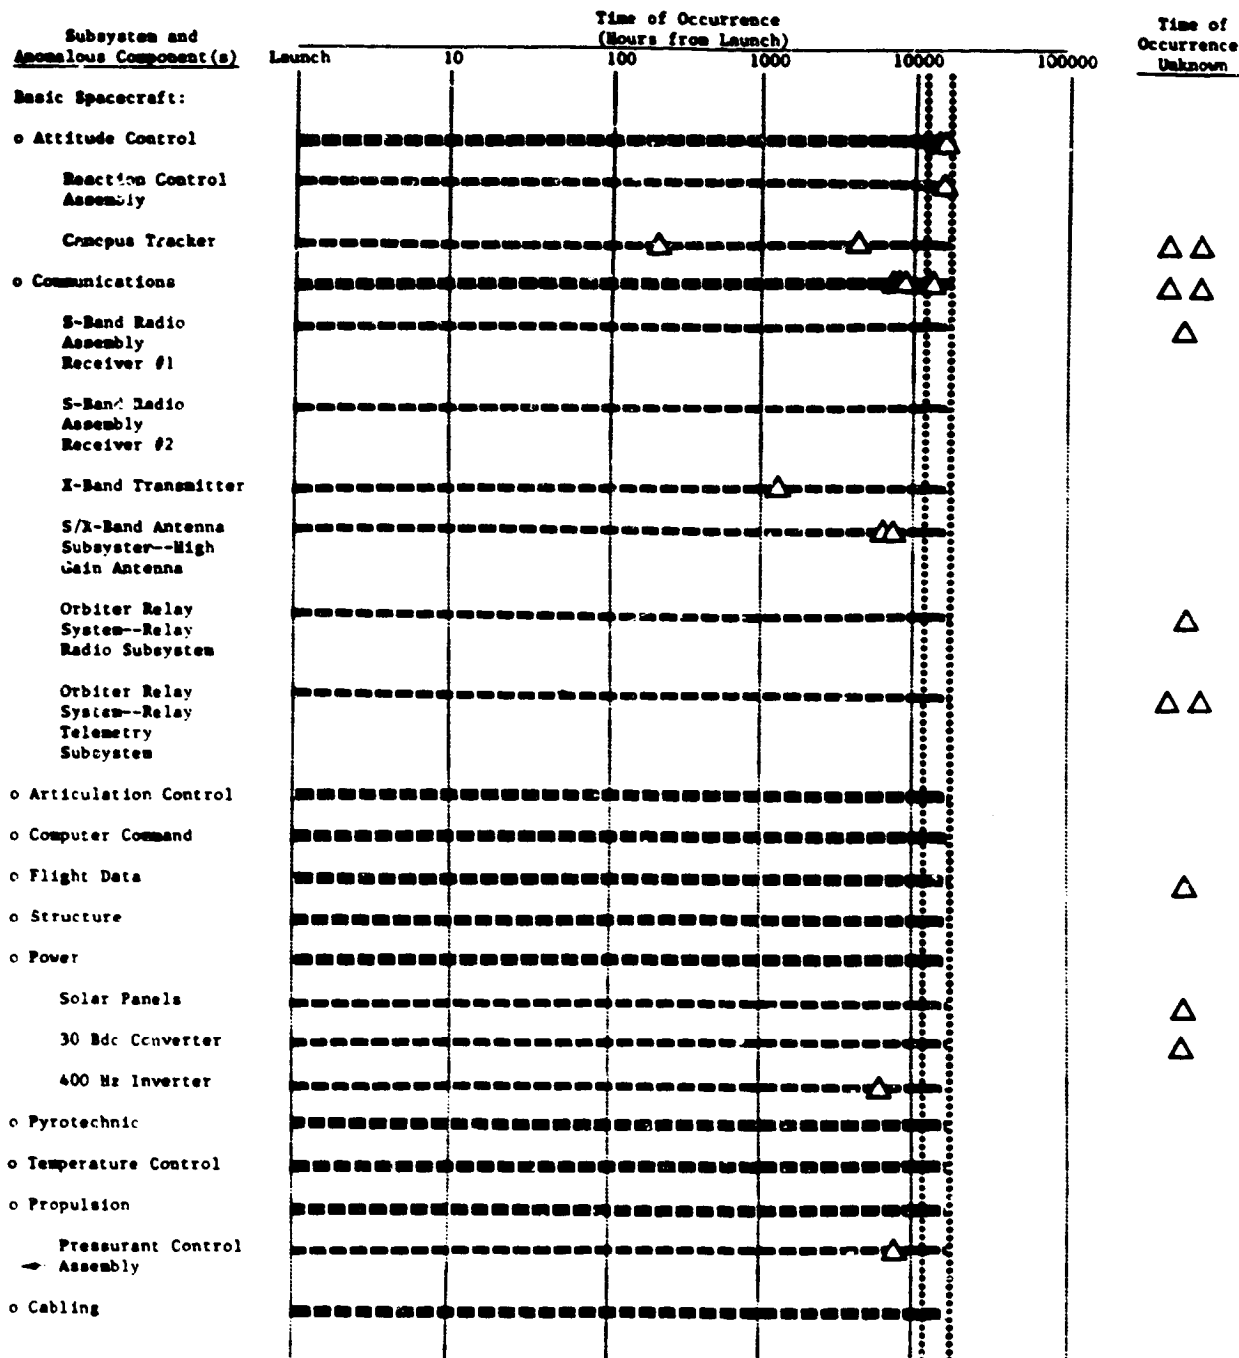
PERFORMANCE SUMMARY FOR VIKING ORBITER 2

Design Life:
11,088 hours
(15 Months)

End of Data:
24,936 hours;
Viking Orbiter II was
shutdown due to
depletion of gas.

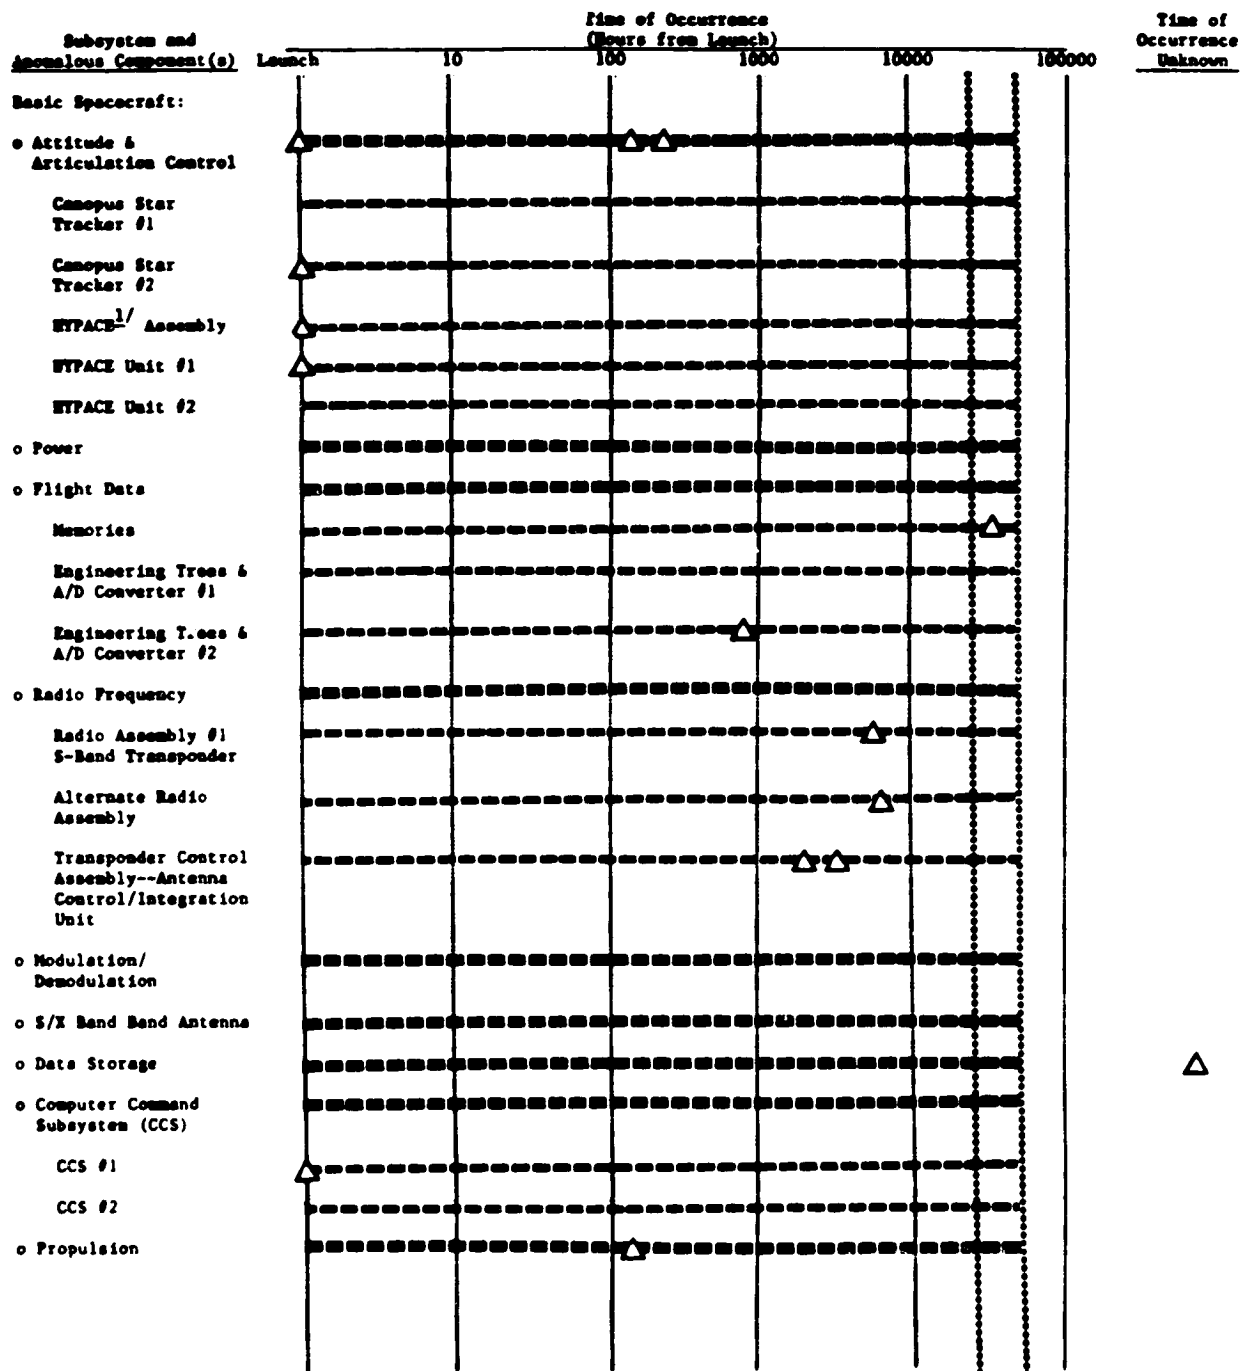
PERFORMANCE SUMMARY FOR VOYAGER 2

Design Life:
26,280 hours
(3 Years)

End of Data:
46,296 hours;
Voyager 2 is still
operating.
